## **Unexpected Discoveries**

## Spirit & Odyssey continue their mission in 7th year

by Jim Oberg

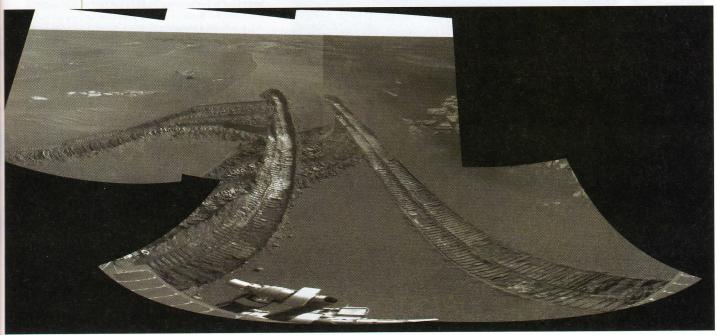
This view from the navigation camera on NASA's Mars **Exploration Rover Opportunity** shows tracks left by backing out of a wind-formed ripples after the rover's wheels had started to dig too deeply into the dust and sand of the ripple. The frames combined in this view were taken on the 1.867th Martian day, or sol, of Opportunity's mission on Mars (April 25, 2009).

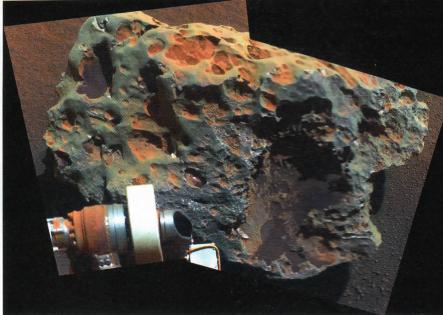
This view of a rock called "Block Island," the largest meteorite yet found on Mars, comes from the panoramic camera (Pancam) on NASA's Mars Exploration Rover Opportunity. Analysis of Block Island's composition using the rover's alpha particle X-ray spectrometer confirmed that it is rich in iron and nickel. The rock is about 60 centimeters (2 feet) across. This is a false-color, red-green-blue composite view generated from images taken through the Pancam's 750-nanometer, 530-nanometer and 430-nanometer filters. The exaggeraged color is used to enhance the visibility of differences among the types of rock and soil materials.

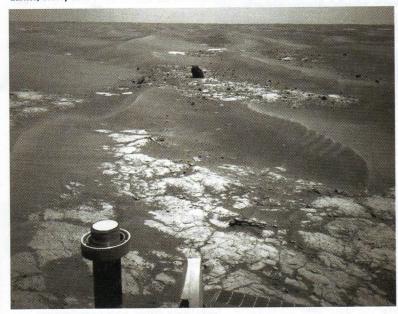
NASA's Mars Exploration Rover Opportunity took this picture of a rock informally named "Marquette Island" as the rover was approaching the rock for investigations that have suggested the rock is a stony meteorite. Opportunity used its navigation camera to record this image during the 2,056th Martian day, or sol, of the rover's mission on Mars (Nov. 5, 2009).
